**LOWER LAKE NIMHAM DAM  
PUTNAM COUNTY, NEW YORK**

NY 137

**PHASE I INSPECTION REPORT  
NATIONAL DAM SAFETY PROGRAM**

JOSEPH S. WARD & ASSOCIATES  
CONSULTING ENGINEERS  
91 ROSELAND AVENUE, P.O. BOX 91  
CALDWELL, NEW JERSEY 07006

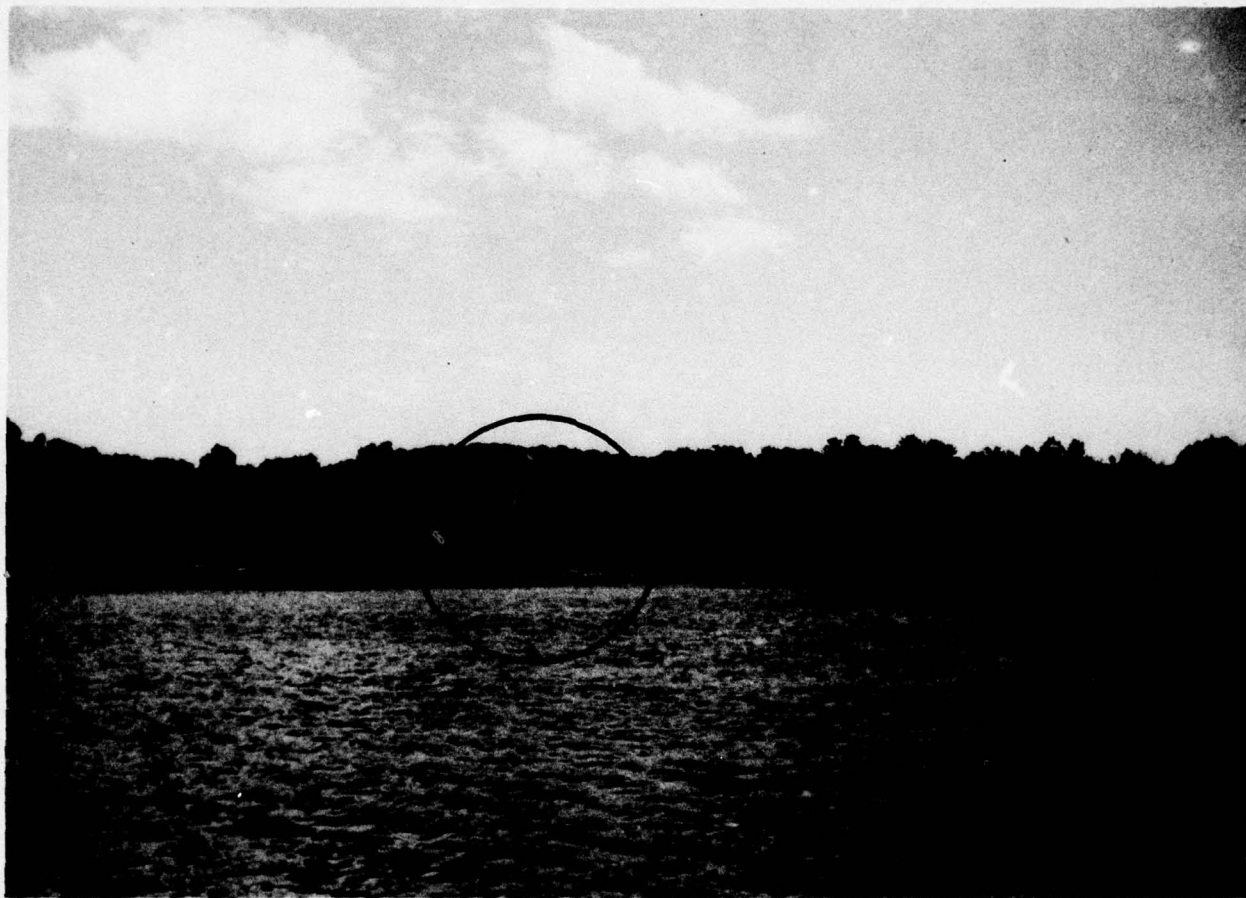
OVERVIEW - LOWER LAKE NIMHAM DAM

There is a trail through the woods that leads from Nimham Drive to the dam on Lower Lake Nimham. The damsite was heavily overgrown with trees and shrubs and, with the water level of the lakes high, it was difficult to locate the dam itself. Figures 3 and 4, taken from the control gate platform, show respectively the left and right upstream portions of the embankment near their junction with the natural terrain. Because of these conditions, it was virtually impossible to obtain a meaningful overview photograph.

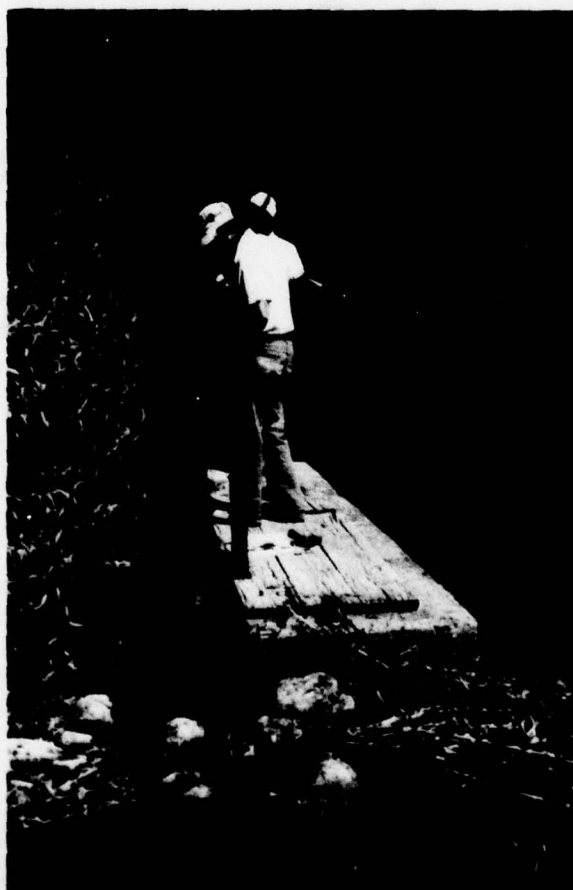
The outlet structure was described previously in Section 1.2a. The concrete surfaces of the overflow inlet chimneys were in good condition with only minor scaling evident. On the day of the inspection, there was about 1 inch of water at the bottom of the chimneys and a slight flow through the 48-inch diameter outlet pipes (Fig. 6, Appendix D). The turning nuts and screw rods of the sluice gate controls were rusted and the gates did not appear to have been operated for some time (Fig. 7, Appendix D). Since a turning wheel or wrench was not available at the Town of Kent offices, and since no representative of the Town of Kent accompanied us during the inspection, the sluice gates were not opened.

FIGURE 2      TWIN CHIMNEY DROP INLET SPILLWAY - LOWER  
LAKE NIMHAM

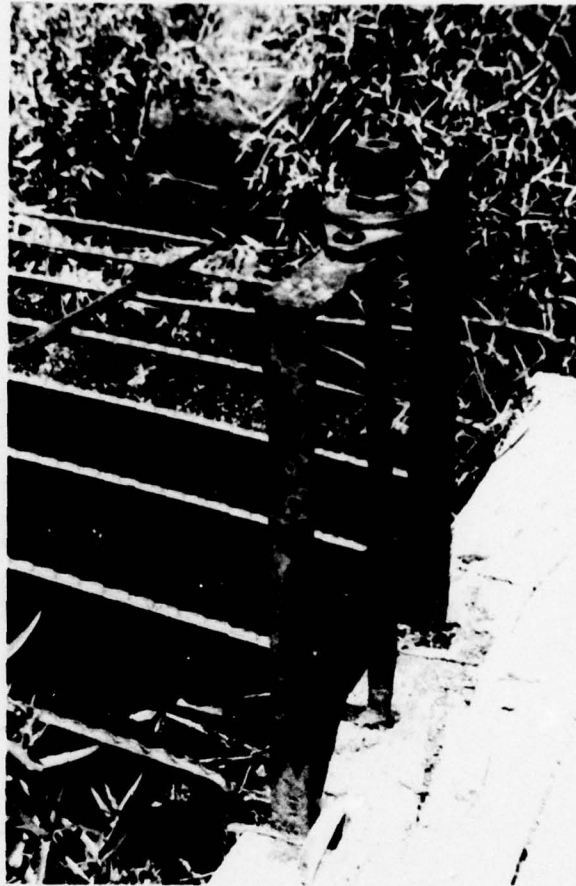
There is evidence that maintenance of operating facilities has been neglected. The riser rods of the sluice gates are beginning to rust and the wooden platform atop the gate boxes could use a coat of preservative or paint.

FIGURE 7      TURNING NUT AND RISER ROD FOR SLUICE GATE

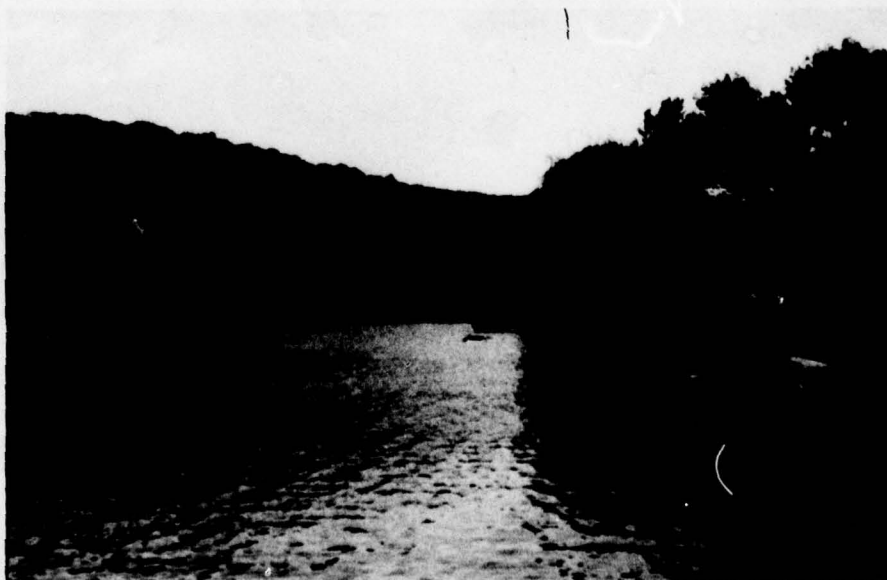
FIGURE 10 TYPICAL RESERVOIR AREA
